# **INDOOR AIR QUALITY ASSESSMENT**

**Clinton Town Hall  
242 Church Street  
Clinton, Massachusetts**

Prepared by:  
Massachusetts Department of Public Health  
Center for Environmental Health  
Emergency Response/Indoor Air Quality Program  
November 2005

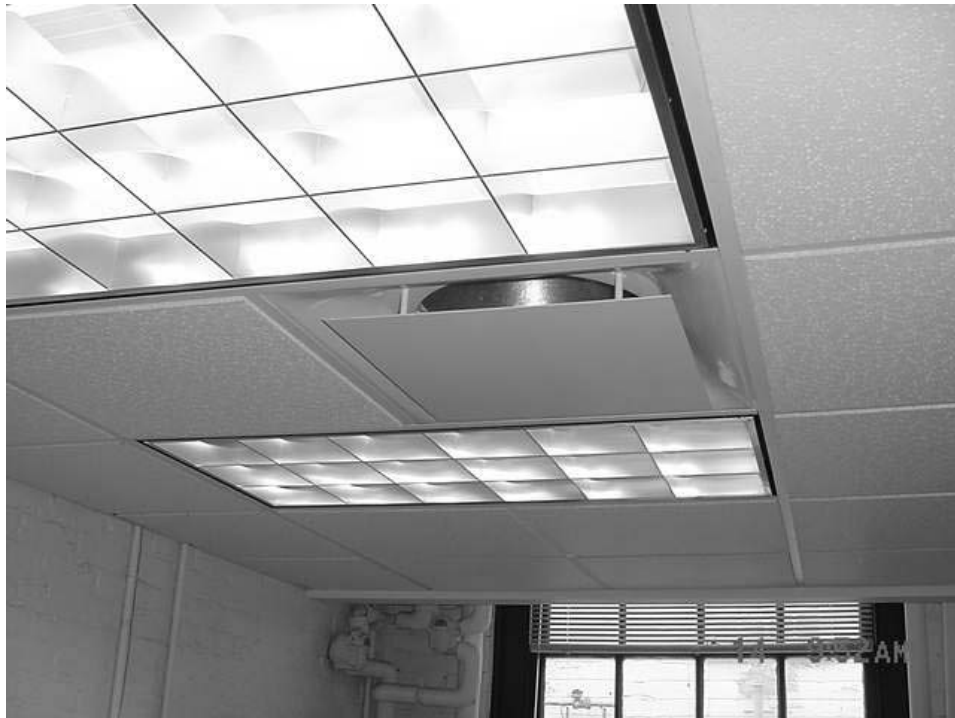
**Picture 1**

It can be seen from the tables that carbon dioxide levels were below 800 ppm (parts per million) in all areas surveyed, indicating adequate ventilation in the building. Fresh, heated air is supplied by air-handling units (AHUs) located in mechanical rooms. Conditioned air is delivered to occupied areas via ceiling or wall-mounted air diffusers (Picture 1). Return air is drawn into the main hallway via passive wall vents (Picture 2) into a return vent ducted back to the AHU (Pictures 2 and 3). Although the request for this assessment was prompted by the malfunction of the buildings HVAC system, Mr. Dickhaut reported that the HVAC system was repaired several days prior to the CEH visit. The system was operating during the assessment.

**Ceiling-Mounted Air Diffuser**

7. Clean supply/return vents periodically of accumulated dust.
8. For further building-wide evaluations and advice on maintaining public buildings, see the resource manual and other related indoor air quality documents located on the MDPH's website at <http://www.state.ma.us/dph/beha/iaq/iaqhome.htm>.

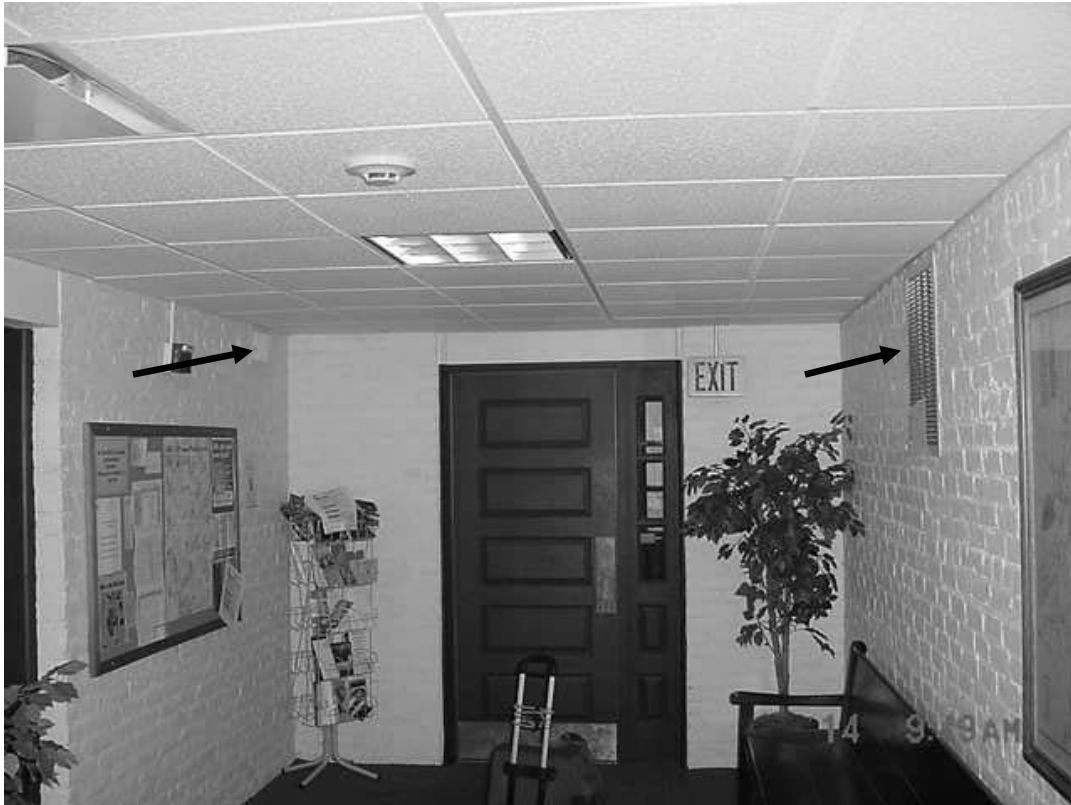
**Picture 2**

**Passive Vent on Left Wall, Central Return Vent on Right Wall**

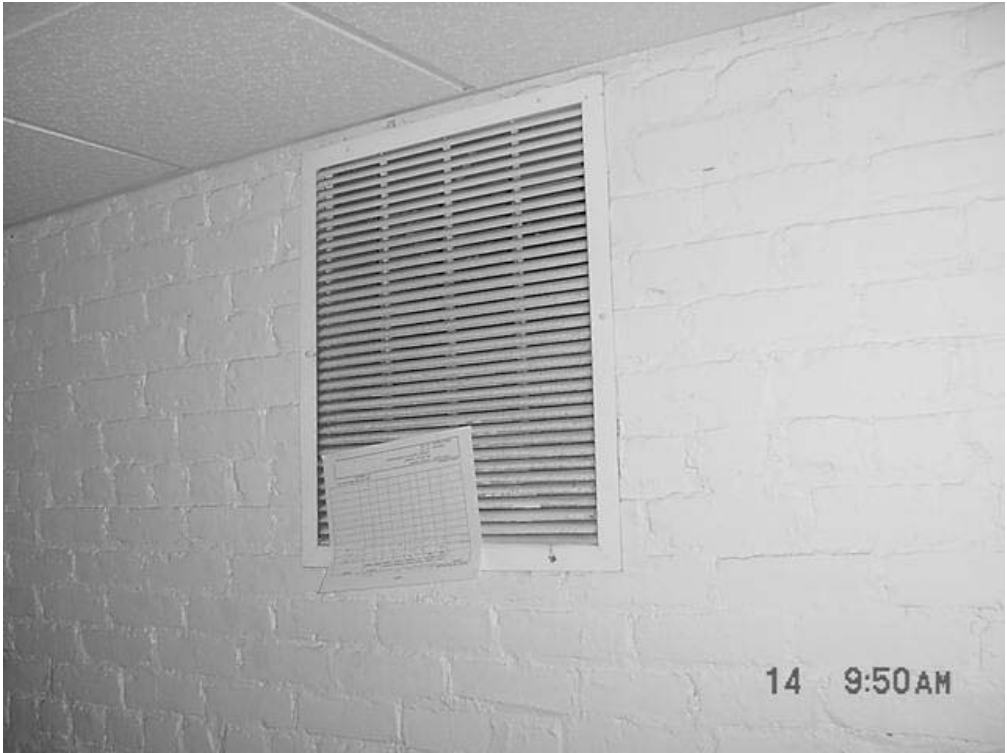
**Picture 3**

**Close-Up of Central Return Vent**

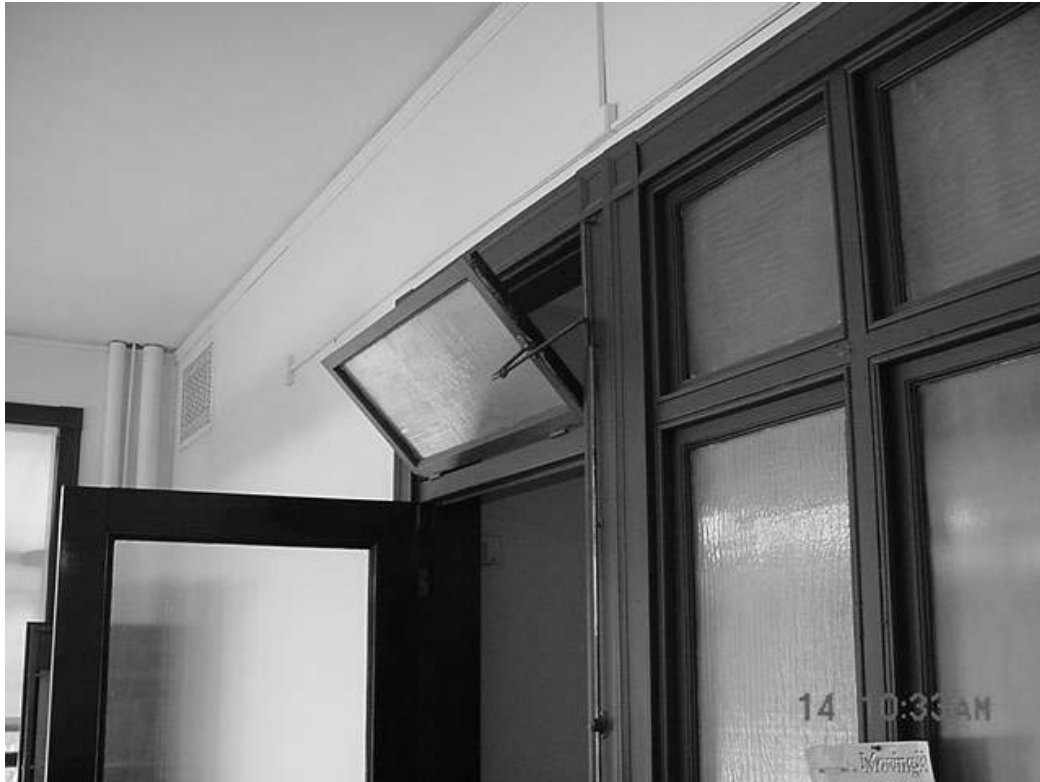
**Picture 4**

The CTH was originally configured to use cross-ventilation to provide comfort for building occupants. The building is equipped with windows on opposing exterior walls. In addition, the building has hinged windows located above the hallway doors. This hinged window (called a transom, Picture 4) enables building occupants to close the hallway door while maintaining a pathway for airflow. This design allows for airflow to enter an open window, pass through an office and subsequently pass through the open

transom. Airflow then enters the hallway, passing through the opposing open office transom, into the opposing room and finally exits the building on the leeward side (opposite the windward side) (Figure 1). With all windows and transoms open, airflow can be maintained in a building regardless of the direction of the wind. The system fails if the windows or transoms are closed (Figure 2). Although some transoms were open during the assessment (Picture 4), others were closed.

**Transom in Use**

4. This building was originally designed to use windows in combination with transoms to provide air exchange. Use openable windows in conjunction with mechanical ventilation to facilitate air exchange. Care should be taken to ensure windows are properly closed at night and weekends to avoid the freezing of pipes and potential flooding.

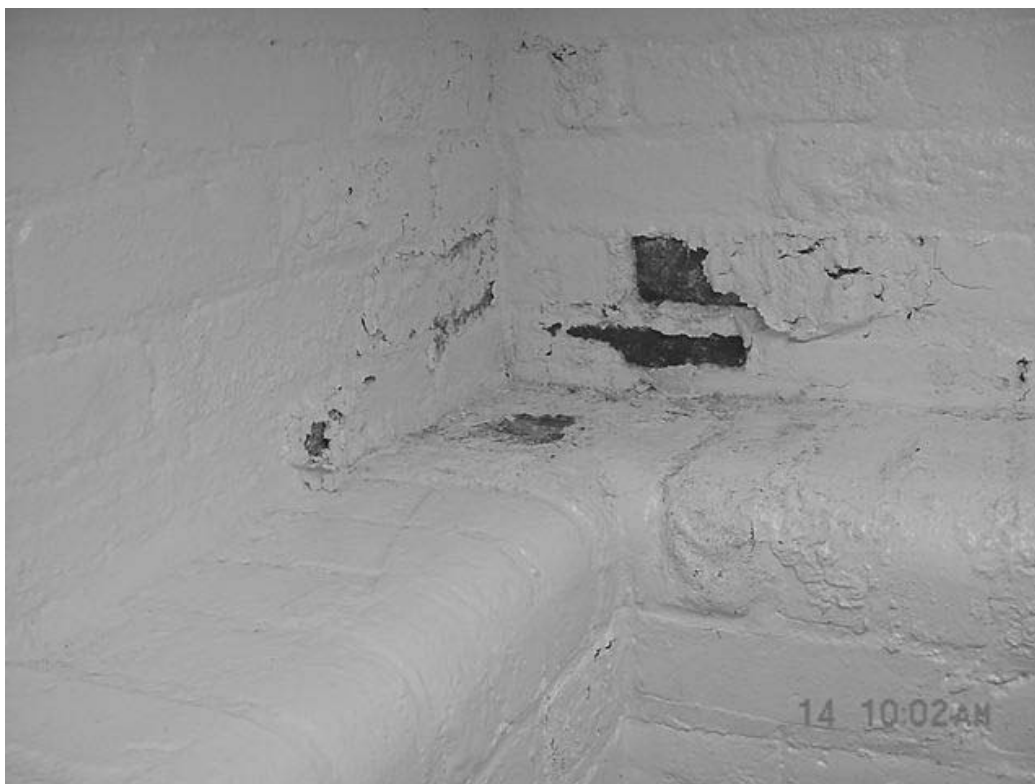
**Picture 5**

Water damaged wall plaster, peeling paint and efflorescence were observed on ceilings and walls in the men's ground floor restroom (Pictures 4 and 5). Water damage and efflorescence are most likely the result of water penetration through the building envelope. Missing/damaged mortar was observed around brick on the exterior wall outside the men's room (Picture 6). Efflorescence is a characteristic sign of water damage to brick and mortar, but it is not mold growth. As moisture penetrates and works its way through mortar and brick, water-soluble compounds in mortar and brick dissolve, creating a solution. As the solution moves to the surface of the mortar or brick, the water evaporates, leaving behind white, powdery mineral deposits.

**Peeling Paint and Efflorescence in the Ground Floor Men's Room**

1. Consider consulting with an architect, masonry firm or general contractor regarding the integrity of the building envelope, primarily concerning water penetration through exterior walls. Ensure all leaks are repaired. Once leaks are repaired, repair water-damaged plaster/paint and examine the feasibility of repointing brickwork.

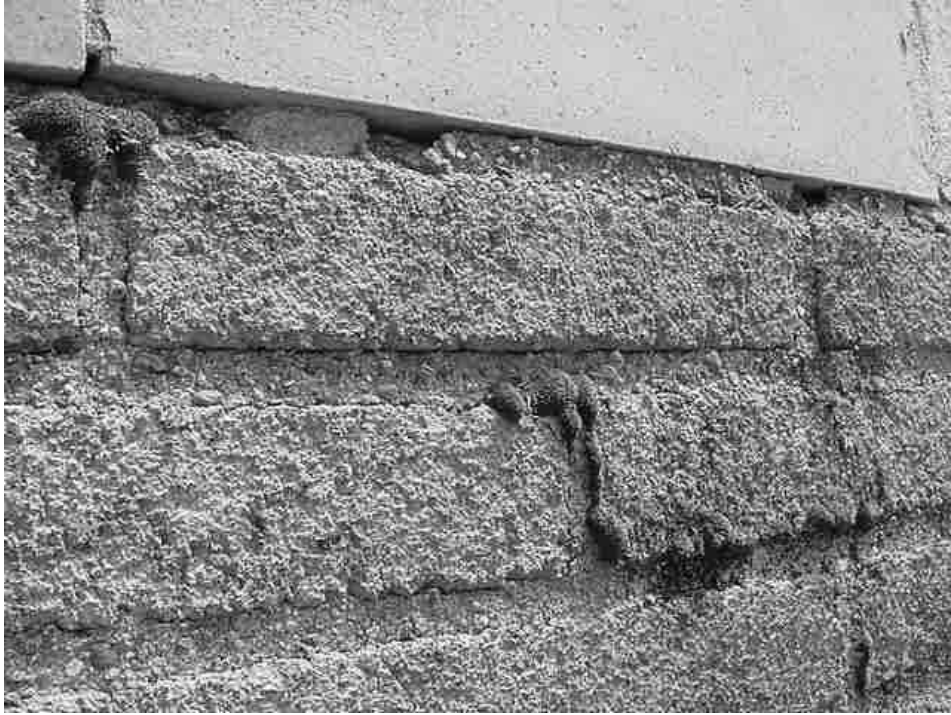
**Picture 7**

**Missing/Damaged Mortar around Brick outside Ground Floor Men's Room, Note Moss Growth Indicating Chronic Moisture**

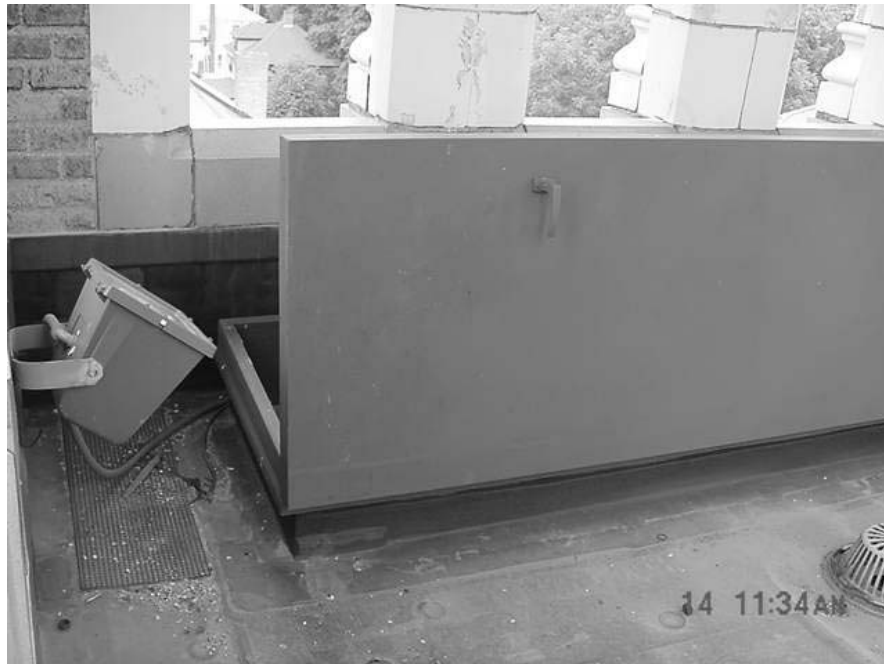
**Picture 9**

Water damaged wall plaster was noted in the selectmen's secretary's office (Picture 7). In this case CEH staff found the bulkhead at the top of the bell tower had been left open (Picture 8) which appeared to allow rainwater penetration, causing the water damage seen in the office. An open utility hole also exists in the bell tower roof (Picture 9), which can serve as another source for water penetration. Water-damaged porous materials can provide a source of mold and should be repaired/replaced after a moisture source is discovered and repaired.

**Open Bulkhead in Bell Tower**

2. Ensure bell tower bulkhead door is kept shut. Seal utility hole in bell tower roof to prevent water penetration.
3. Balance mechanical ventilation systems every five years, as recommended by ventilation industrial standards (SMACNA, 1994). Consult a ventilation engineer concerning re-balancing of the ventilation systems.

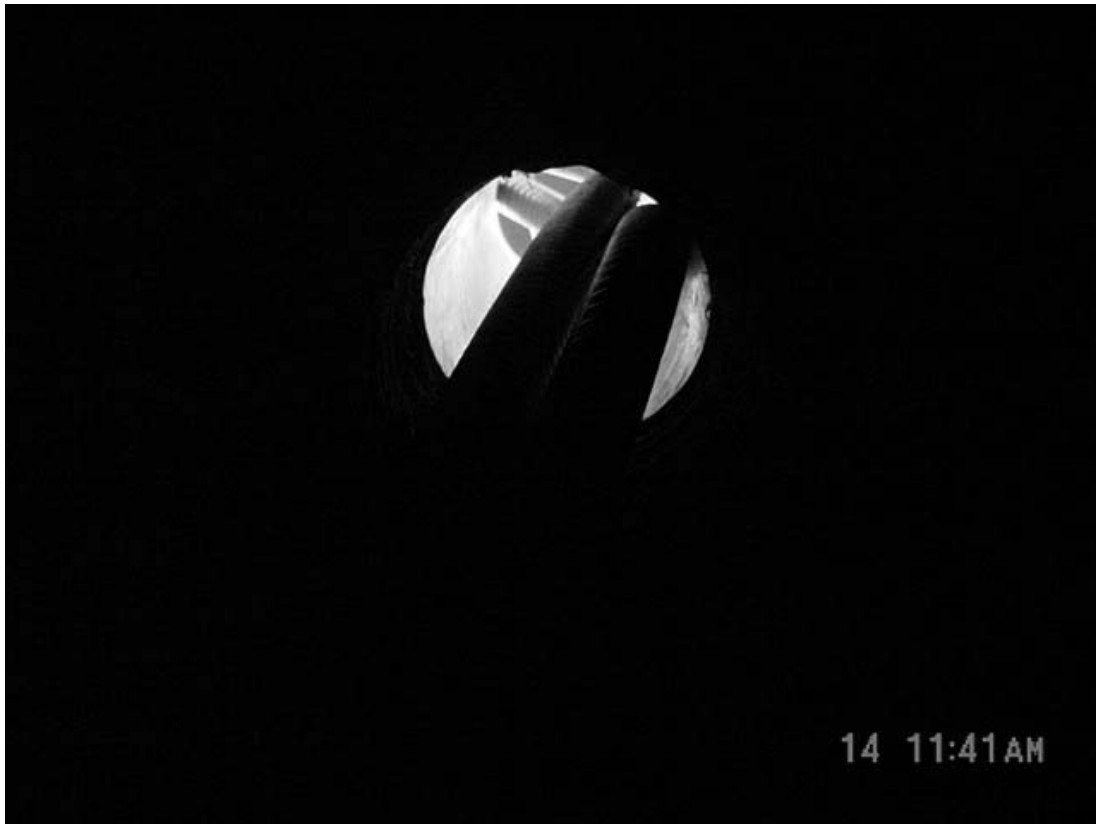
**Picture 10**

**Open Utility Hole in Bell Tower Roof**

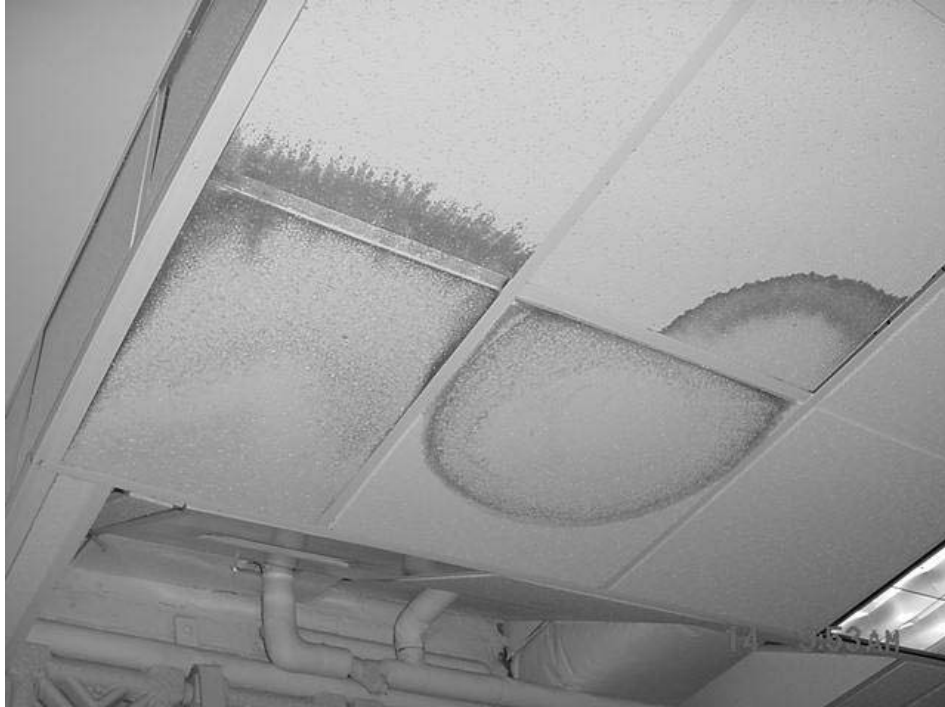
**Picture 11**

A few areas had water damaged ceiling tiles (Picture 10). Water-damaged ceiling tiles can be a medium for mold growth. The ceiling tiles should be replaced after a water leak is discovered.

**Water Damaged Ceiling Tiles in Ground Floor**

5. Ensure leaks are repaired and replace water damaged ceiling tiles. Examine the areas above and around these tiles for mold growth. Disinfect areas of water leaks with an appropriate antimicrobial.
